Structure Name	<input type="text" value="Waubuno Street Bridge"/>		
Main Highway #	<input type="text" value="Waubuno Street"/>	On <input checked="" type="checkbox"/> or Under <input type="checkbox"/>	Service on Structure
			<input type="checkbox"/> Navig. Water <input type="checkbox"/> Non-Navig. Water <input type="checkbox"/> Rail <input type="checkbox"/> Road <input checked="" type="checkbox"/> Ped. <input type="checkbox"/> Other
Location Description	<input type="text" value="Waubuno Street at Georgian Bay"/>	Service under:	<input type="checkbox"/> Navig. Water <input type="checkbox"/> Non-Navig. Water <input type="checkbox"/> Rail <input checked="" type="checkbox"/> Road <input type="checkbox"/> Ped. <input type="checkbox"/> Other
Owner/Custodian	<input type="text" value="Town of Parry Sound"/>		
MTO Region	<input type="text" value="Northeastern"/>	Latitude	<input n"="" type="text" value="45° 20' 34"/>

Field Inspection Information:					
Date of Inspection:	June 29, 2022	Type of Inspection:	<input checked="" type="checkbox"/> Reg. OSIM	<input type="checkbox"/> Enh. OSIM	
Inspected By	Alison Friebel				
Others in Party:	Brian Wood, P.Eng.				
Eng. Access Equipment:	Camera, Tape m

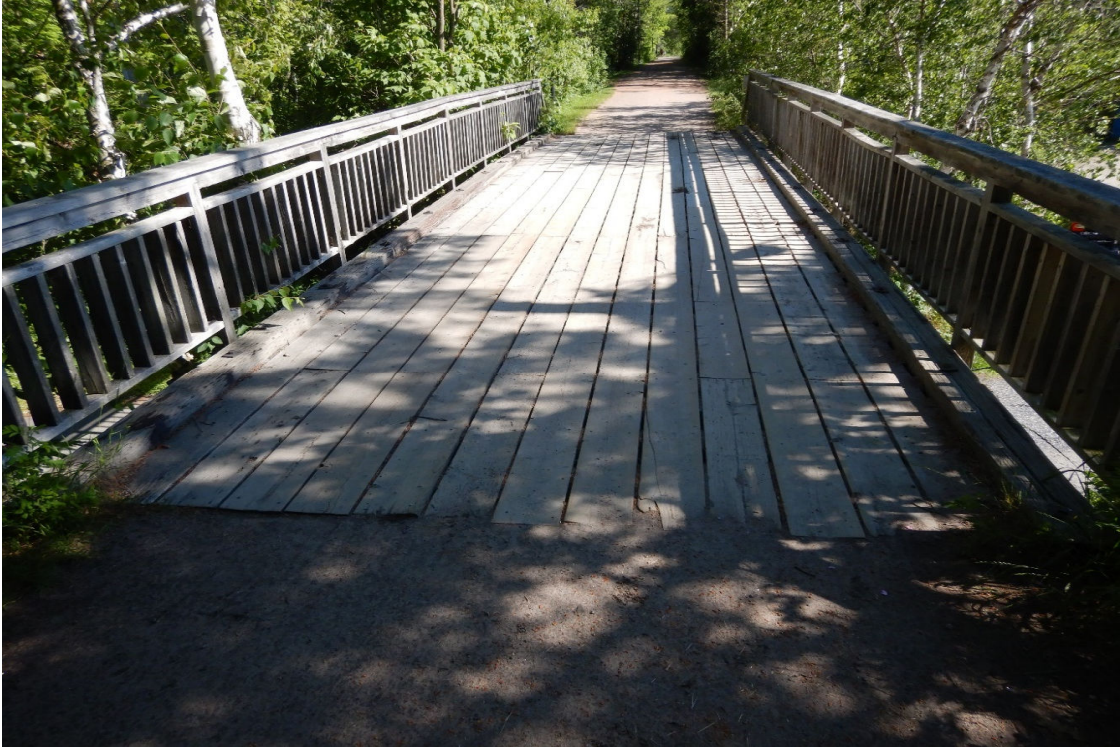
Description of Photo:		Deck Top

Replace rottent planks				Fasten loose planks			
Element Photo:

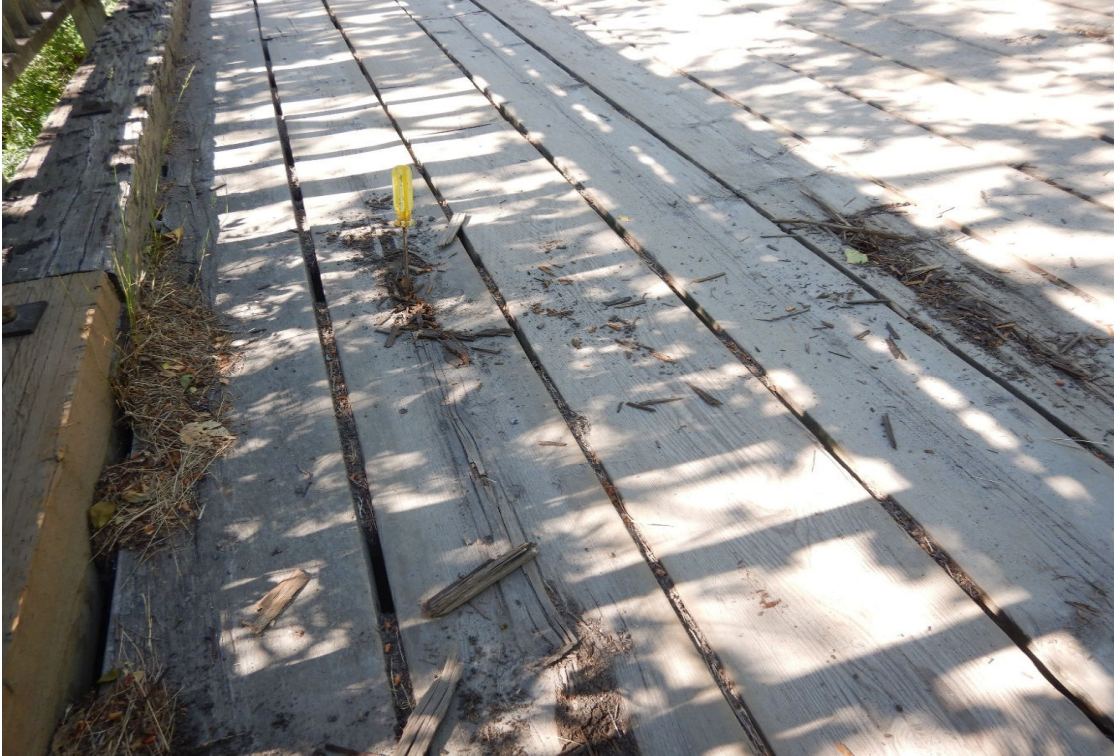
Description of Photo: Deck Top rot

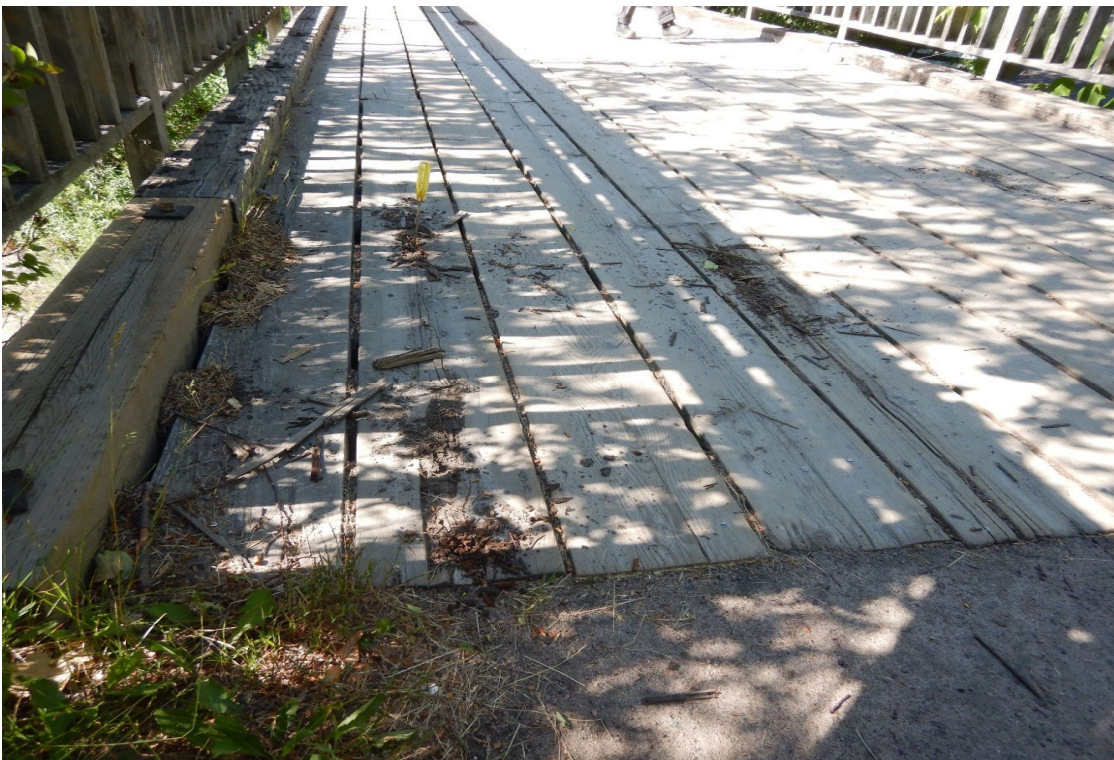
Description of Photo: Deck Top rot

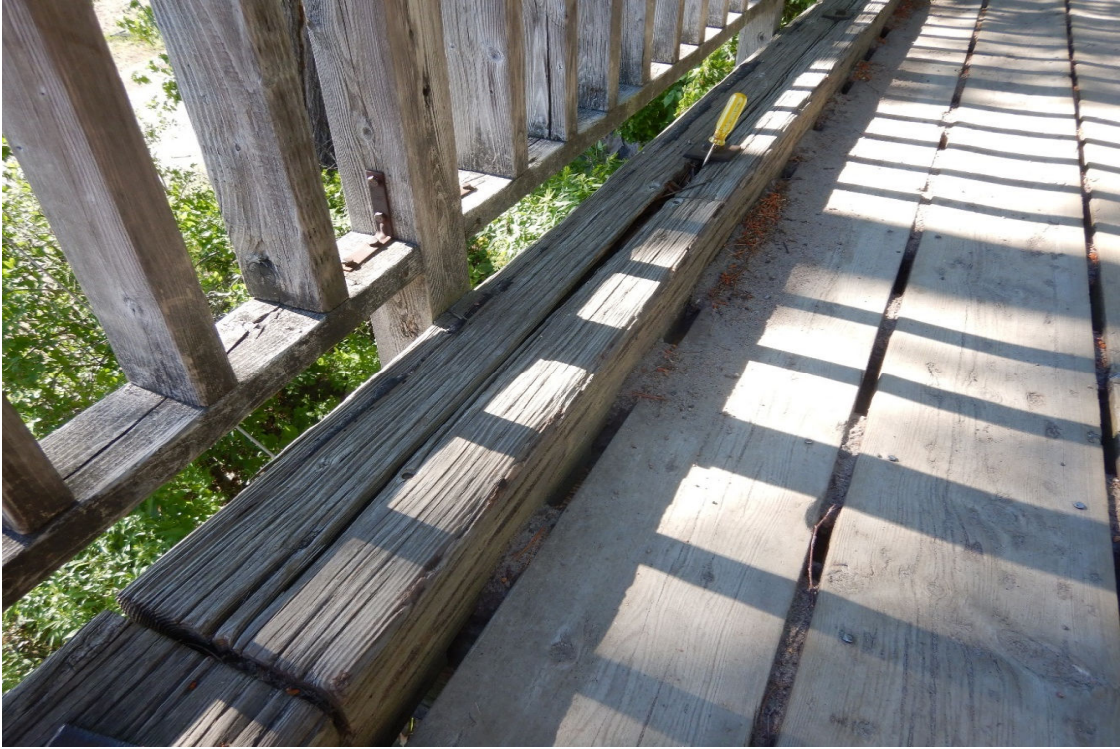
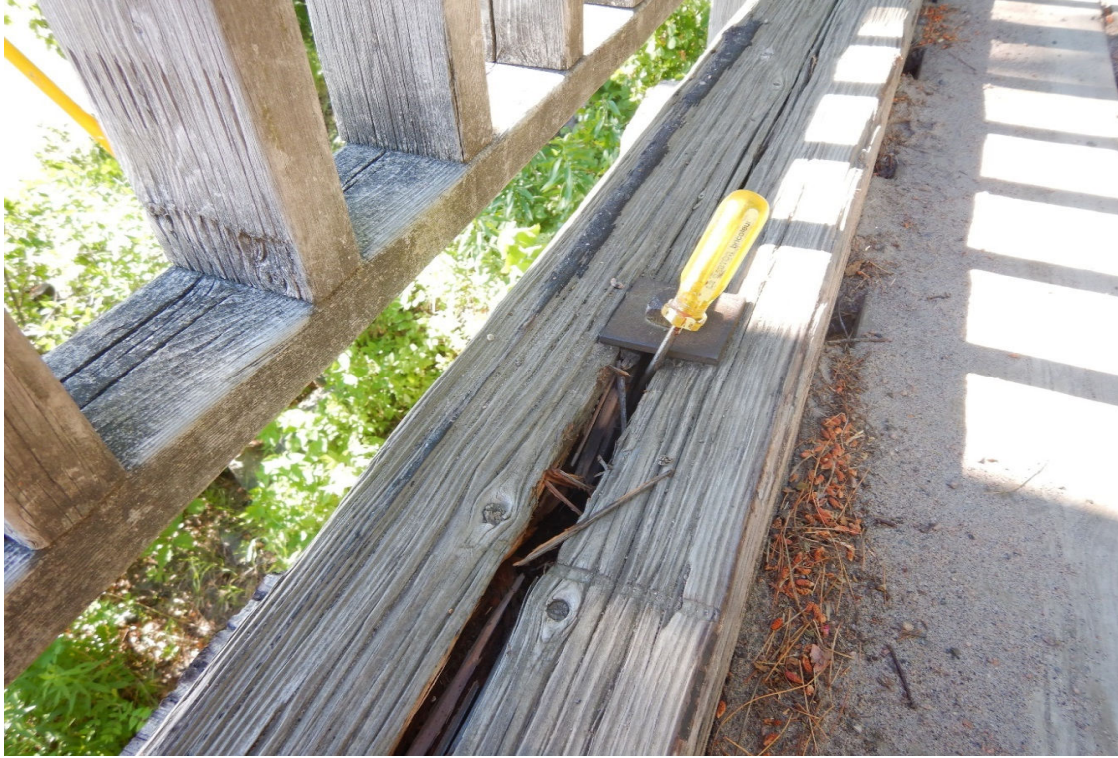
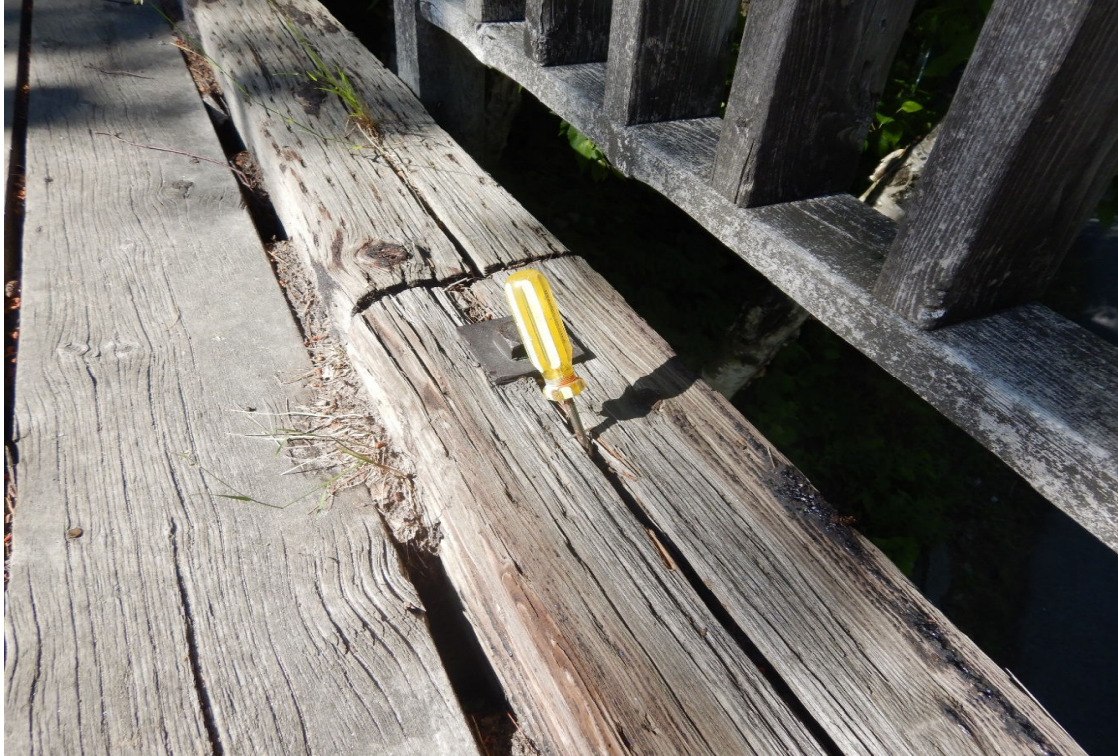
Description of Photo:		Curb

Description of Photo: Curb

Replace rotten timbers							
Element Photo:

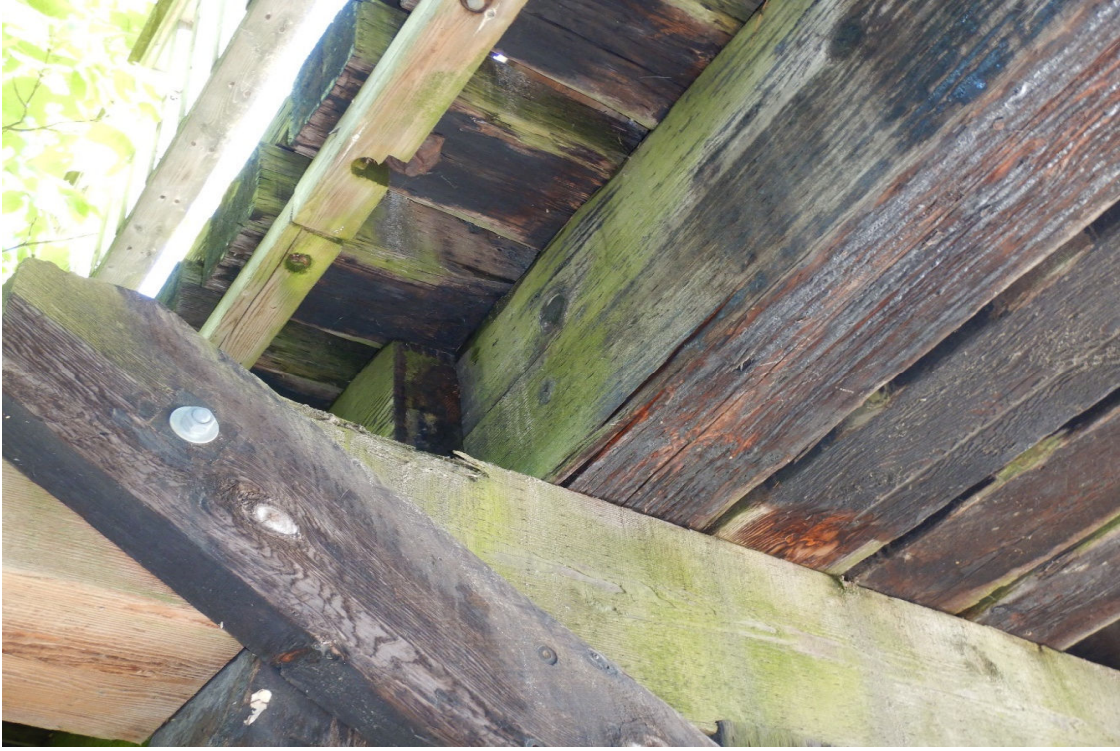
Element Data:							
Element Group:	Beams/Main Longitudinal Elements		Length:	3.73, 4.18, 3.53			
Element Name:	Stringers		Width:	0.25			
Location:			Height:	0.45			
Material:	Wood		Count:	18			
Element Type:	Rectangular Solid		Total Quantity:	288.3			
Environment:	Benign		Inspected	Yes <input checked="" type="checkbox"/>	No <input type="checkbox"/>	limited <input type="checkbox"/>	
Protection System:	Creosote						Performance Deficiencies
Condition Data:	Units	Excellent	Good	Fair	Poor*		
	sq.m		244.1	28.8	15.4	1 - Load carrying capacity	
Comments: Light weathering typical. Isolated medium to severe checks and splits. Center span light splintering on the east and west exterior stringers, likely from vehicle impact. North span center stringer 2.0m of rot from abutment with severe bulging, 2nd girder from west 2.0m of rot from abutment, 6th stringer has 1.0m of rot from abutment with severe bulging and 8th stringer has 1.0m of rot from abutment. South span at pier 3rd and 7th stringer has 1.0m of rot from pier, 7th stringer has 1.0 of rot from abutment. Center span at south pier 9th stringer has 1.0m of rot from pier and 8th stringer has 1.0m of rot from north pier.

Description of Photo:		Centre span 9th stringer

Recommended Work:		Rehab: <input checked="" type="checkbox"/>	Replace: <input type="checkbox"/>	Maintenance Needs:			
Urgent: <input type="checkbox"/>	1-5 Years: <input checked="" type="checkbox"/>	6-10 Years: <input type="checkbox"/>	None: <input type="checkbox"/>	Urgent: <input type="checkbox"/>	1 Year: <input type="checkbox"/>	2 Year: <input type="checkbox"/>	
Replace 8 rotten stringers							
Element Photo:

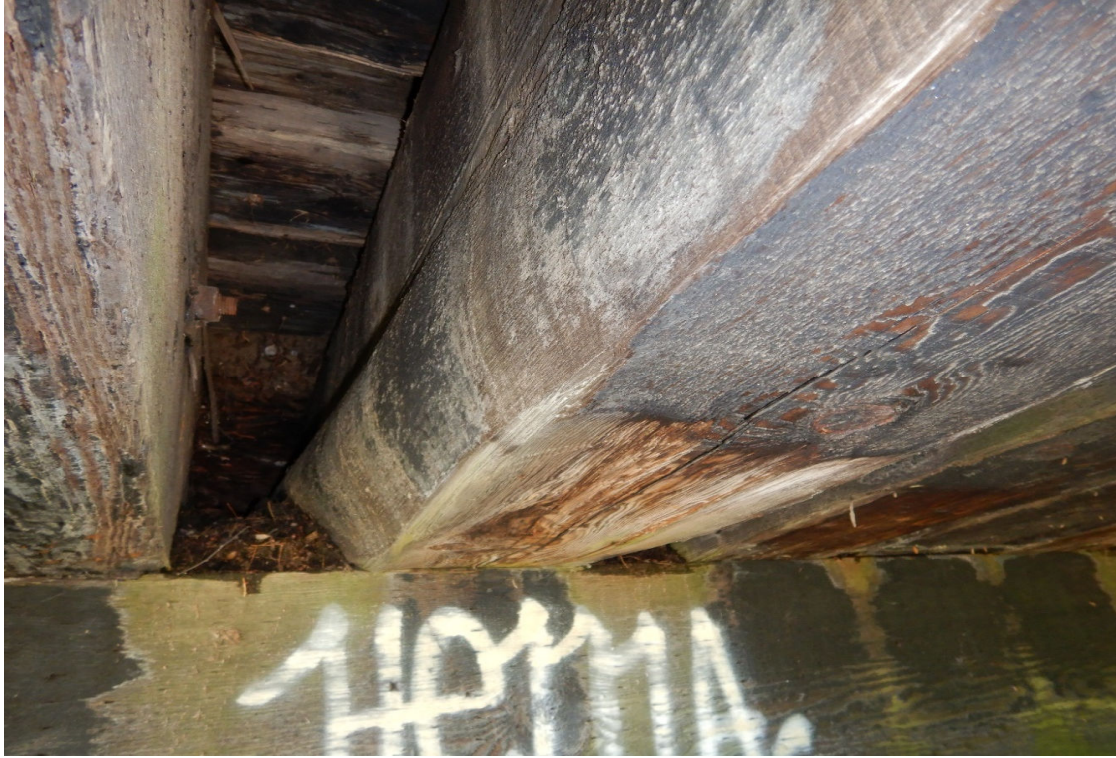
Description of Photo: North span 5th stringer rot and bulging

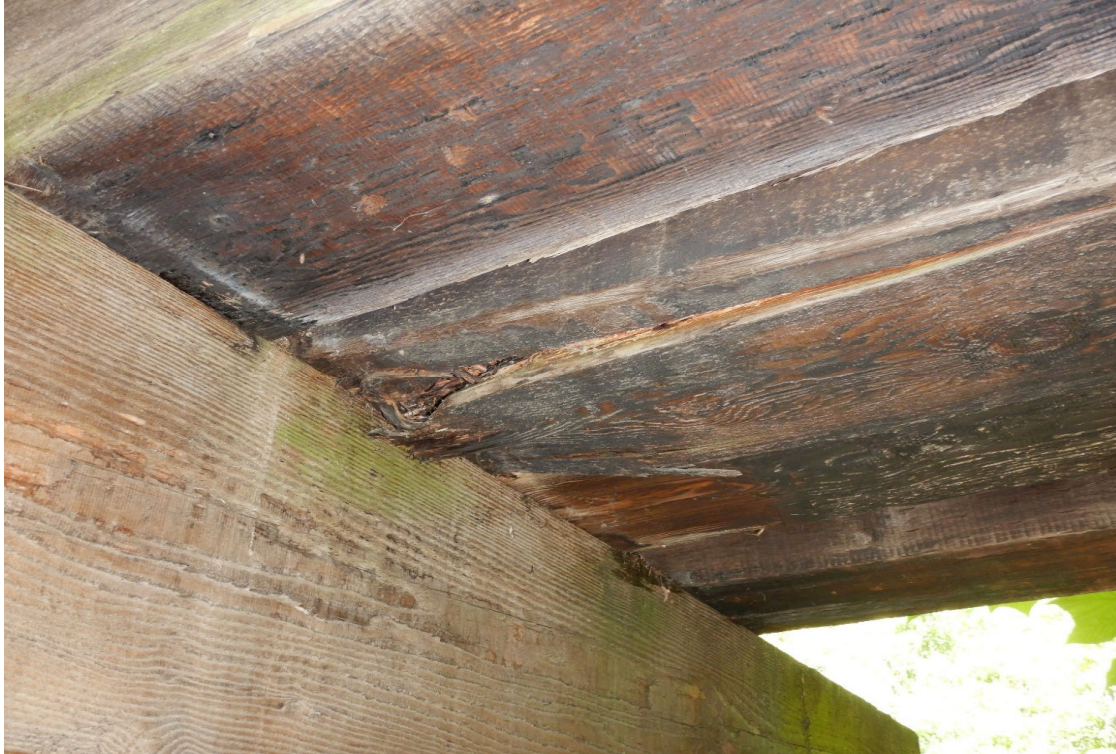
Description of Photo: South span 7th stringer rot

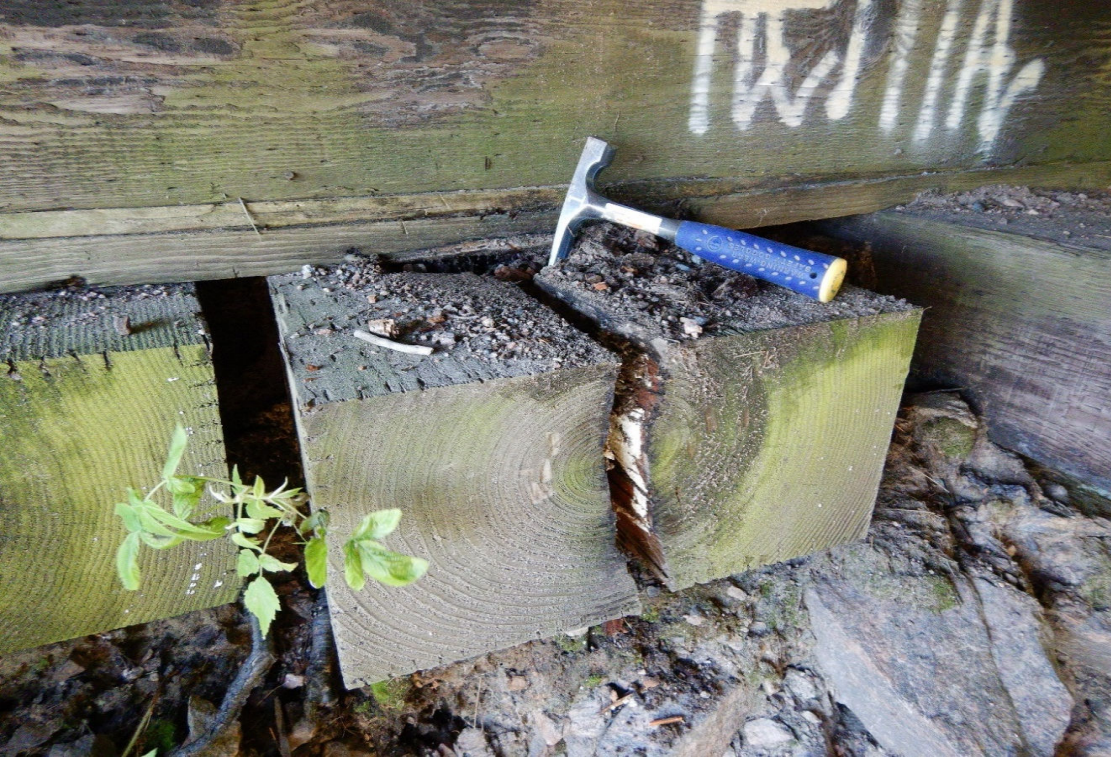
Description of Photo: Sill Check

Replace poor timber sills							
Element Photo:

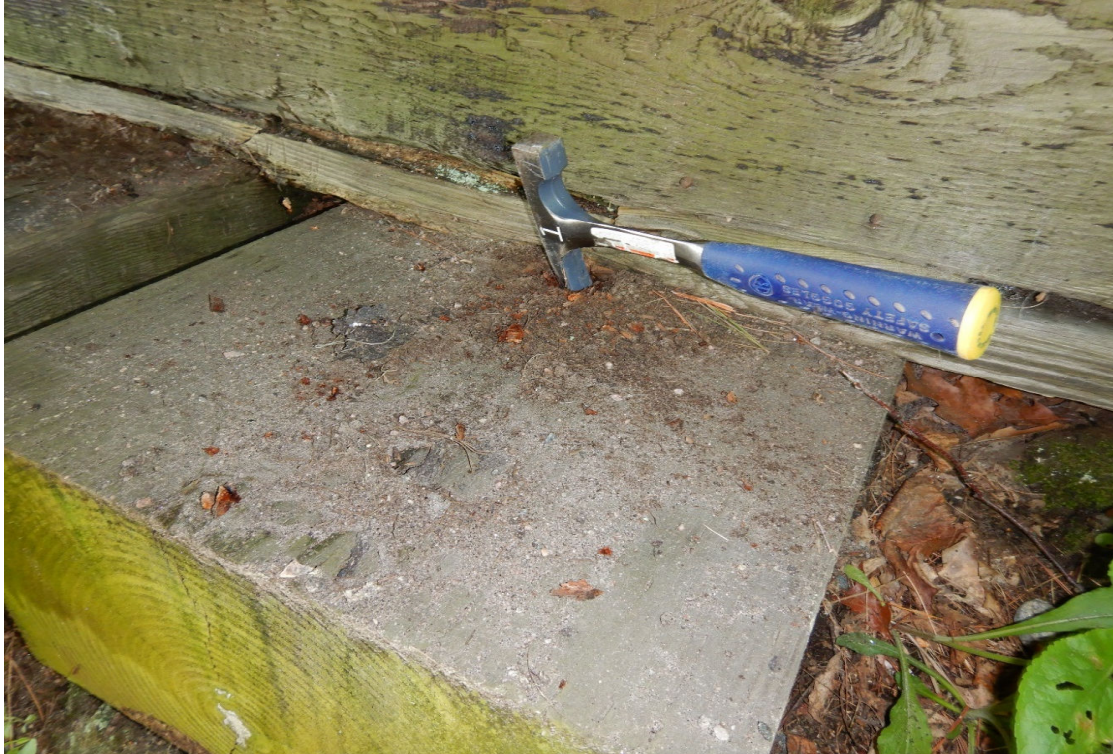
Description of Photo: Sill Rot

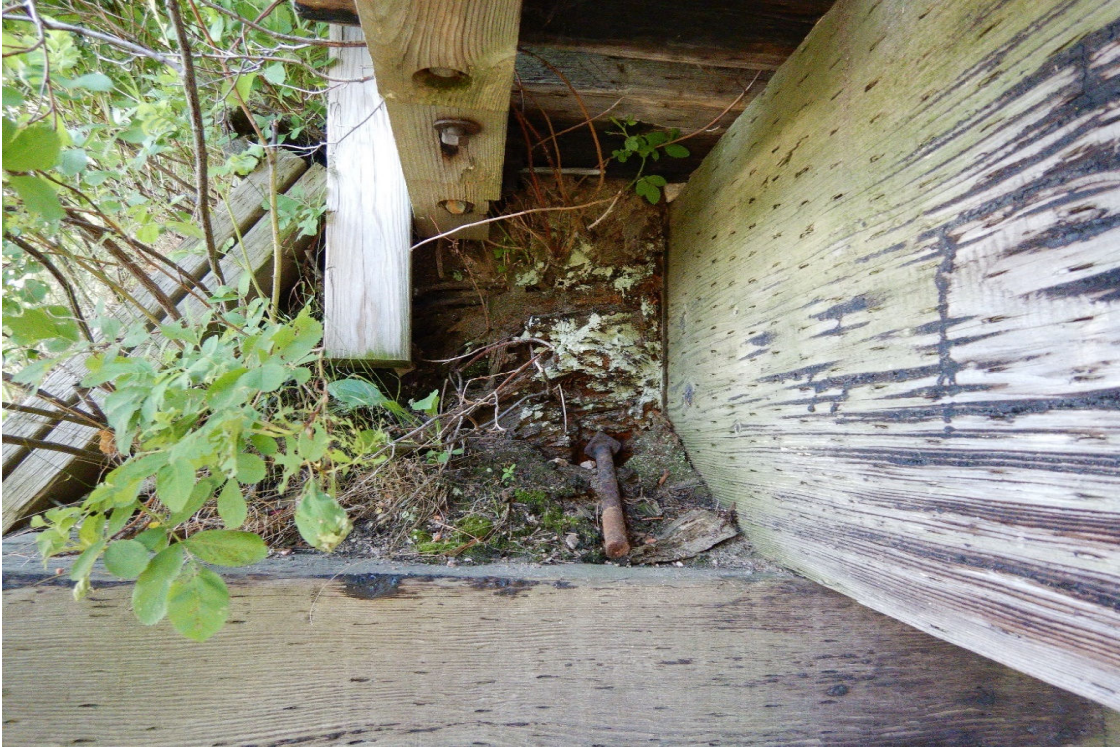
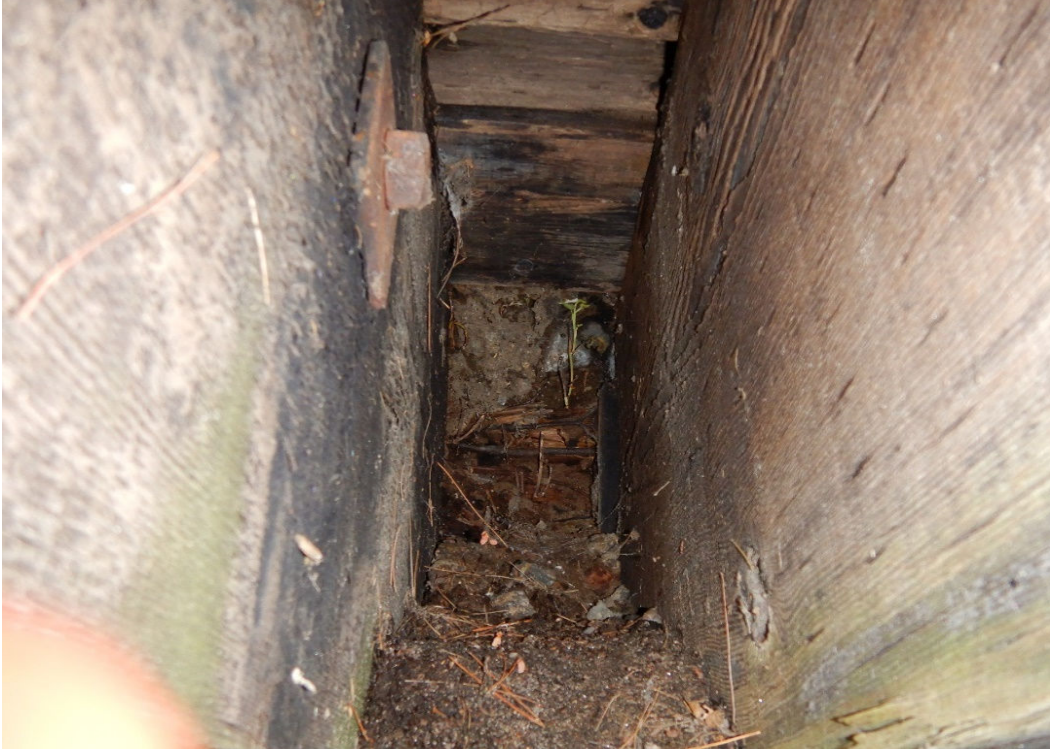
Description of Photo:		South Ballast Wall, Rot

Description of Photo: South Ballast Wall, Rot

Replace south ballast wall						
Element Photo:

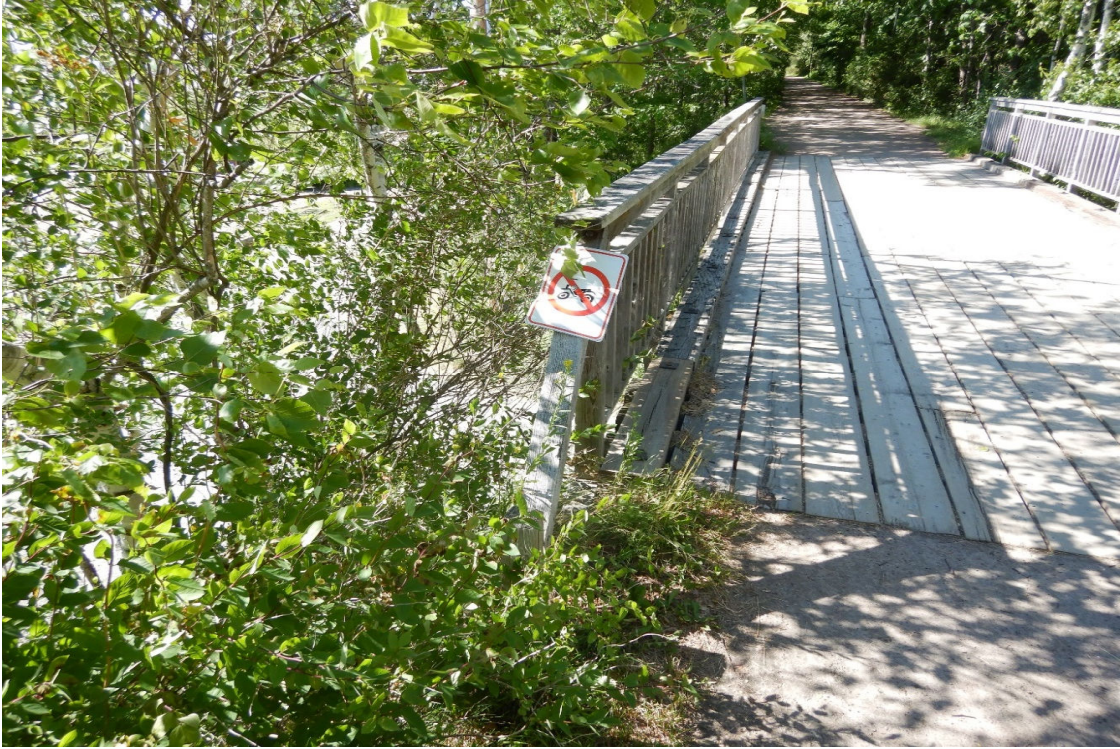
Description of Photo:		No motorized vehicles sign

Relocate no motorized vehicles to be easily visible.			
Element Photo:
